Discolourisation
and
Pipe Characterisation

A case study of root cause analysis for tackling discolouration through intelligent online monitoring.

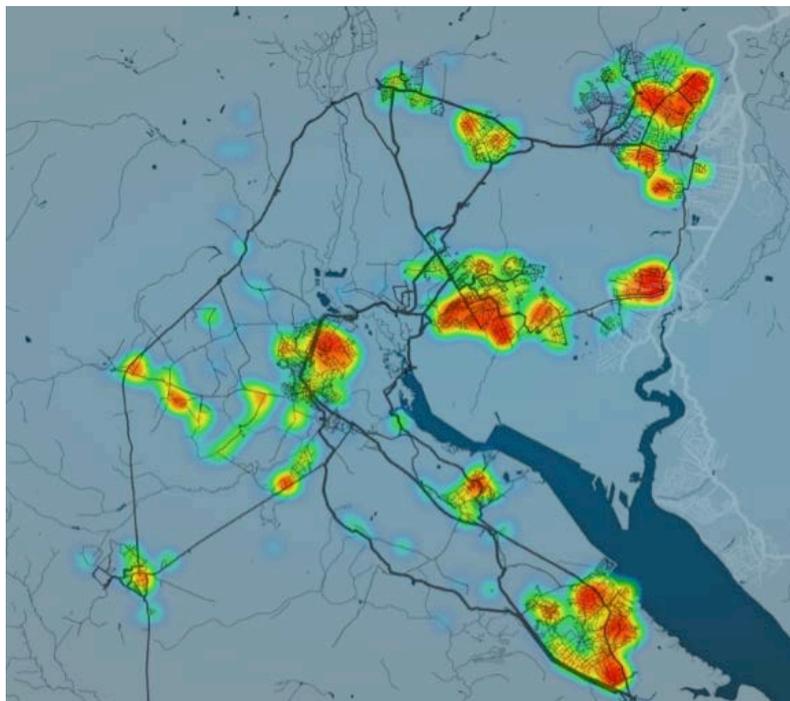
Intellitect were approached by a UK water utility to assist them in finding out why one of their water networks was having so many customer contacts regarding discoloured water. At the beginning of the project, the water utility knew where their customer complaints were but with little idea about where the discoloured water might be coming from.

This created the following heatmap of complaints:

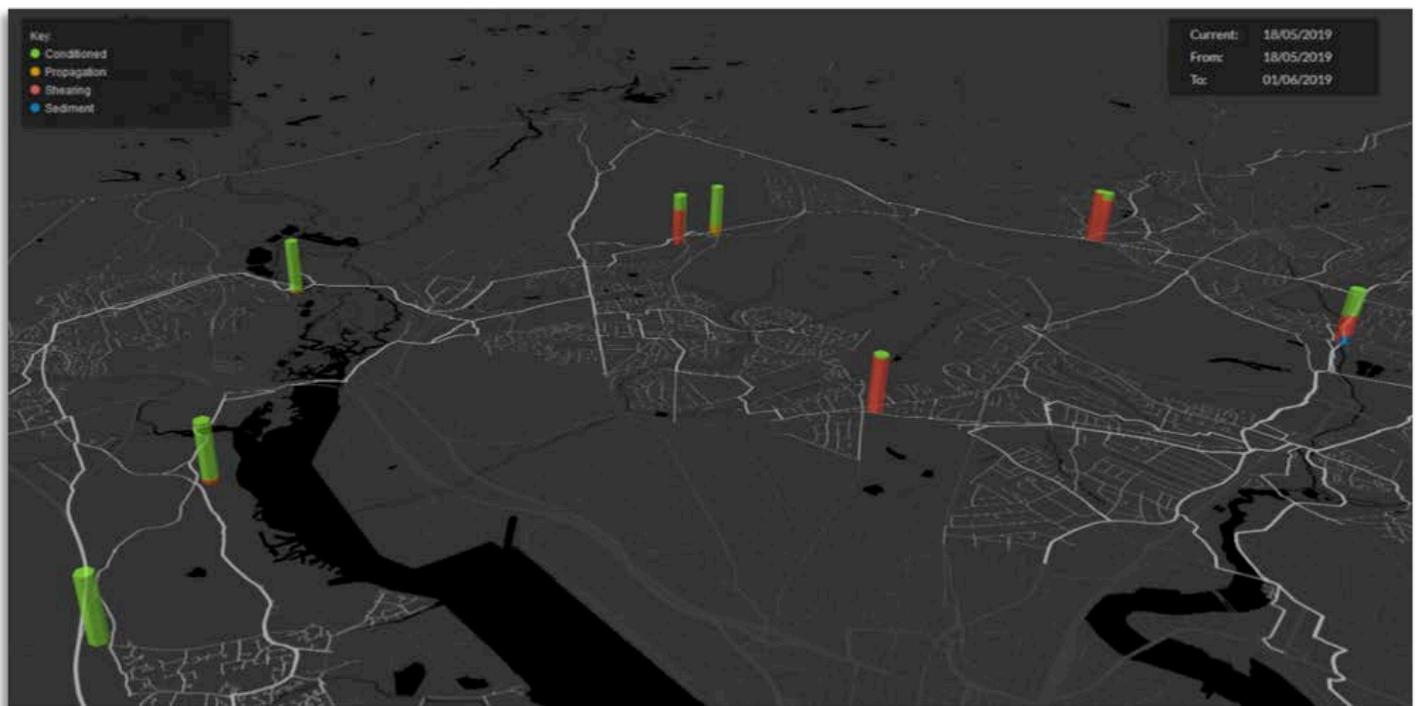
Through the analysis on our Insight platform, we are able to see this geospatially and identify the problem areas and the root cause at those places:

- **Conditioned pipes** – low risk of turbidity problems (green)
- **Propagation** – discolouration issues originate upstream and propagate down (orange)
- **Local Shearing** – discolouration issues originate locally from material shedding off of the pipe walls during times of higher flow (red)
- **Sediment** – Material is stirred up with any amount of flow, indicating that it is not attached to the walls, but is instead settling on the bottom of the pipe (blue)

It is clear from the geospatial analysis in Insight, that there is a ring-main structure in the network which was causing poor conditioning of the pipes. This meant that material was shearing off locally in these pipes and propagating around the ring-main. When it reached the balance point in the ring-main, it settled out and formed sediment – as can be seen by the blue portion on the right-hand side of the figure.

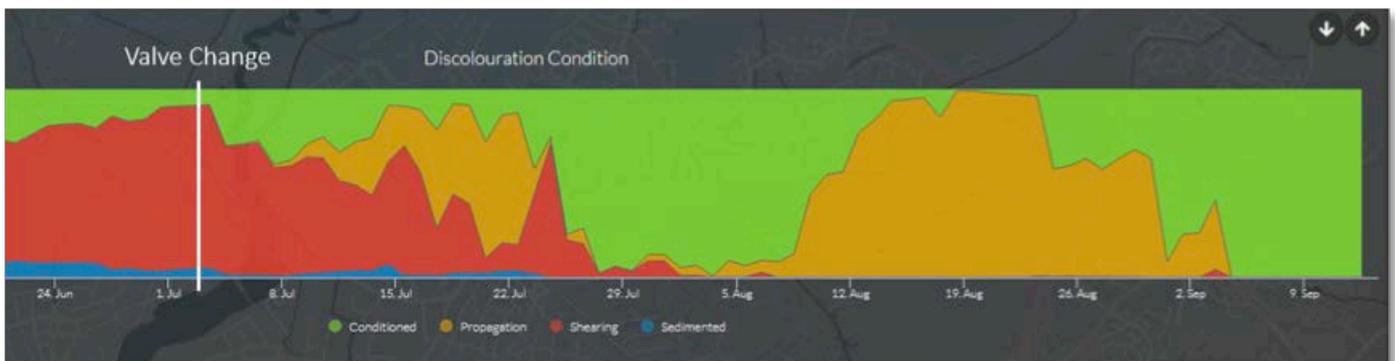
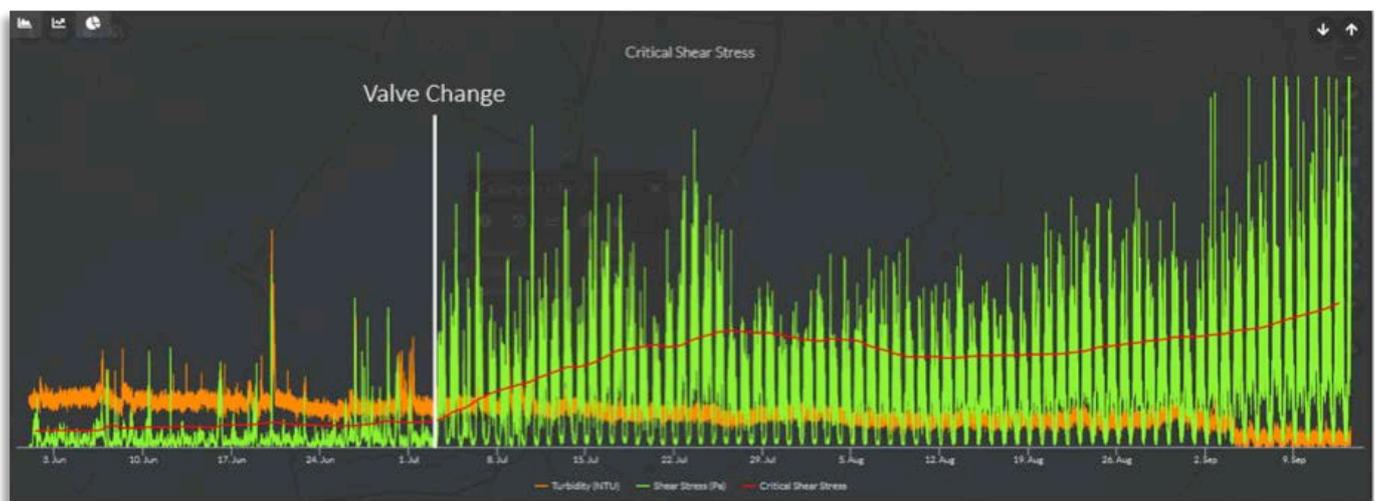
From network monitoring we had identified that the root cause of the discolouration issues was poor conditioning of the pipes resulting in material building up on the pipe walls, which then broke off in periods of high demand or bursts. This caused large discolouration events resulting in high numbers of customer complaints. Once the root cause had been established, we investigated ways in which the pipes could be conditioned. As these were large trunk mains, flushing was not an option and would have a limited effect on the trunk main itself.

Instead, we identified a transfer point to a neighbouring network that had its own water source, yet the transfer was left open. We proposed that in order to change the conditioning in the pipes, it would be possible to close this valve, thus changing the balance point in the network and conditioning the pipes that were causing the discolouration issues. This change was made and within a few weeks the pipe characterisation had showed a marked improvement which could be tracked through our Insight platform. Once the pipes had been conditioned, it would be possible to reopen the valve and return the network to its original configuration. In this way the network can be dynamically managed to condition the pipes and remove the discolouration risk.
