Discolourisation
and
Pipe Characterisation

A case study of root cause analysis for tackling discolouration through intelligent online monitoring.

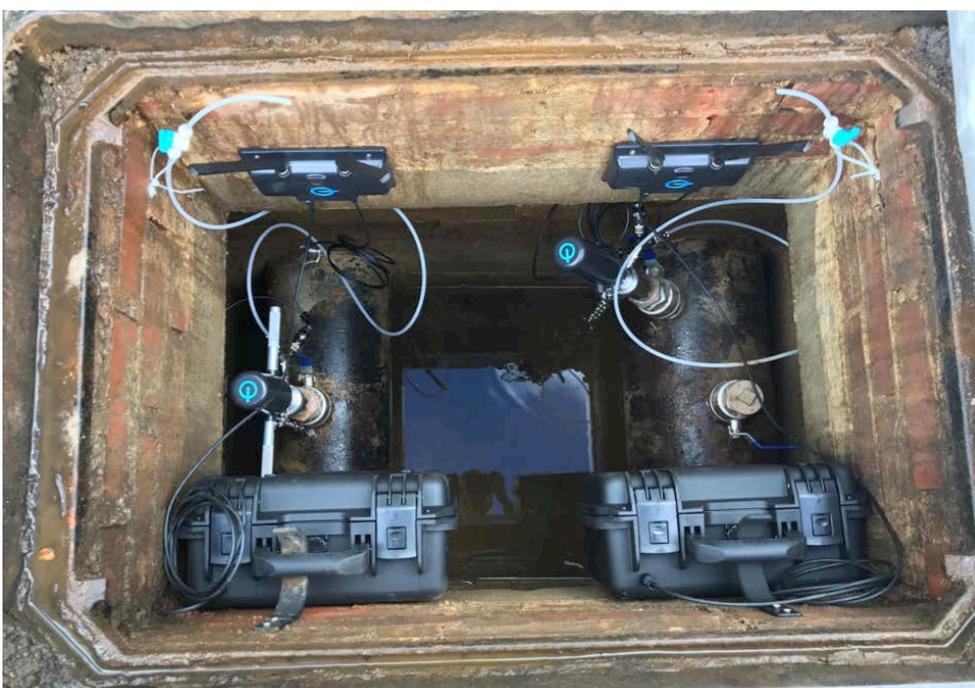
Through the analysis on our Insight platform, we are able to see this geospatially and identify the problem areas and the root cause at those places:

- **Conditioned pipes** – low risk of turbidity problems (green)
- **Propagation** – discolouration issues originate upstream and propagate down (orange)
- **Local Shearing** – discolouration issues originate locally from material shedding off of the pipe walls during times of higher flow (red)
- **Sediment** – Material is stirred up with any amount of flow, indicating that it is not attached to the walls, but is instead settling on the bottom of the pipe (blue)

It is clear from the geospatial analysis in Insight, that there is a ring-main structure in the network which was causing poor conditioning of the pipes. This meant that material was shearing off locally in these pipes and propagating around the ring-main. When it reached the balance point in the ring-main, it settled out and formed sediment – as can be seen by the blue portion on the right-hand side of the figure.

Instead, we identified a transfer point to a neighbouring network that had its own water source, yet the transfer was left open. We proposed that in order to change the conditioning in the pipes, it would be possible to close this valve, thus changing the balance point in the network and conditioning the pipes that were causing the discolouration issues. This change was made and within a few weeks the pipe characterisation had showed a marked improvement which could be tracked through our Insight platform. Once the pipes had been conditioned, it would be possible to reopen the valve and return the network to its original configuration. In this way the network can be dynamically managed to condition the pipes and remove the discolouration risk.
